Re: Essroc San Juan Cement  
Compliance Evaluation Inspection, May 29, 2015 and  
Consent Decree (3:09-cv-01578)  
Individual Permit No. PR0001163 and MSGP 2008 Tracking No. PRR05BJ45

**Compliance Evaluation  
Inspection:**

Essroc San Juan Cement

Individual Permit – PR0001163  
MSGP 2008 - PRR05BJ45

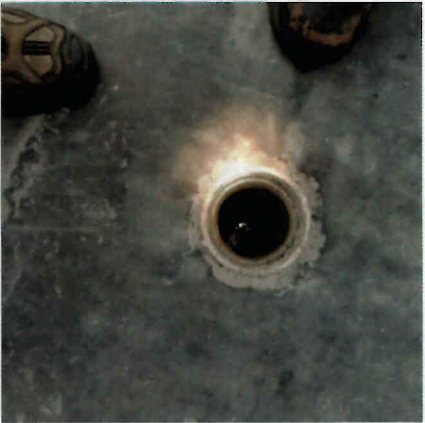
<b>photo ID</b>	<b>Description</b>
DSCN2711	Potential water line leak that runs into channel between Ponds 1 and 2.
DSCN2712	Potential water line leak that runs into channel between Ponds 1 and 2.
DSCN2713	Potential water line leak that runs into channel between Ponds 1 and 2.
DSCN2714	Potential water line leak that runs into channel between Ponds 1 and 2.
DSCN2715	Wastewater storage tank.
DSCN2716	Wastewater storage tank.
DSCN2717	Wastewater Level in wastewater in tank is high - but is thought to overflow to tank in 2716
DSCN2718	Channel with gabions that leads from Pond 1 to Pond 2
DSCN2719	Channel with gabions that leads from Pond 1 to Pond 2
DSCN2720	Outfall 001 PR0001163
DSCN2721	Ultrasonic head sensor at weir at Outfall 001 - the sensor is working, but a cap on the sensor is missing and Essroc will work to replace.
DSCN2722	Ultrasonic head sensor at weir at Outfall 001 - the sensor is working, but a cap on the sensor is missing and Essroc will work to replace.

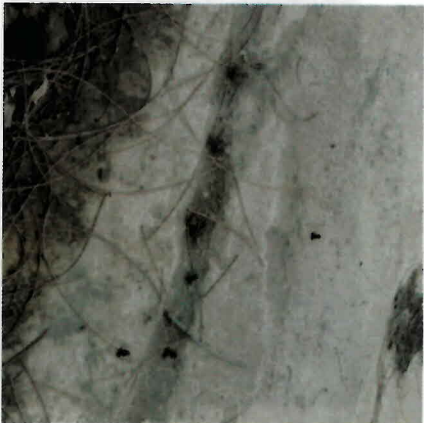
DSCN2745	Continuous flow chart for Outfall 001
DSCN2746	Influent to Pond No. 2 (Internal Sampling Point L2) where gabion channel enters Pond No. 2
DSCN2747	Anura metamorphs near Pond No. 1
DSCN2748	Pond No. 1
DSCN2749	Pond No. 1
DSCN2750	Wastewater tanks behind office area
DSCN2751	Water accumulation in area behind office
DSCN2752	Air conditioners behind office.
DSCN2753	Large amount of sediment accumulated in stormwater channel/basin near the packing house.
DSCN2754	Large amount of sediment accumulated in stormwater channel/basin near the packing house.
DSCN2755	Trench Drain that is full with sediment - needs to be cleaned
DSCN2756	Finishing Mill No. 3, said that the material storage piles were used as safety berms to avoid equipment falling over steep edge of access way.
DSCN2757	Material storage berms
DSCN2758	Clinker Storage Area
DSCN2759	Oil water separator in "Safety Kleen" Used oil area
DSCN2760	Oil water separator in "Safety Kleen" Used oil area
